# Access Compliance Report Public Rights-of-Way (Curb Ramps)

| Main Street: CHARLOMA_DR | | Cross Street: WOODLAWN_AVE | | Location: | S |
| ADA ID: RPRK220107130138 | Ramp Type: Type 1 - Perpendicular Diagonal Initial Pass/Fail: Fail | | Overall Compliance: No | Severity Score: | 15 |

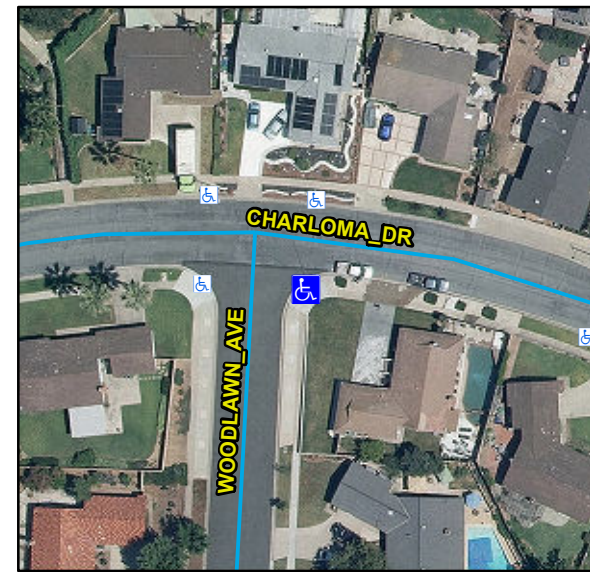
| Compliance | Description | Data | Compliance | Description | Data |
|---|---|---|---|---|---|
| No | Ramp Run Slope (%) | 9 | N/A | Flare Slope LT (%) | N/A |

Possible Solutions:

**Remove & Replace Curb Ramp With Two New Directional Ramps or Equivalent.**

**R304.2.2, STD 1115**
