# Access Compliance Report Public Rights-of-Way (Curb Ramps)

Main Street: KENNETH\_DR Cross Street: WOODLAWN\_AVE Location: S

ADA ID: RPRK220107130935 Ramp Type: Type 1 - Perpendicular Diagonal Initial Pass/Fail: Pass Overall Compliance: No Severity Score: 0

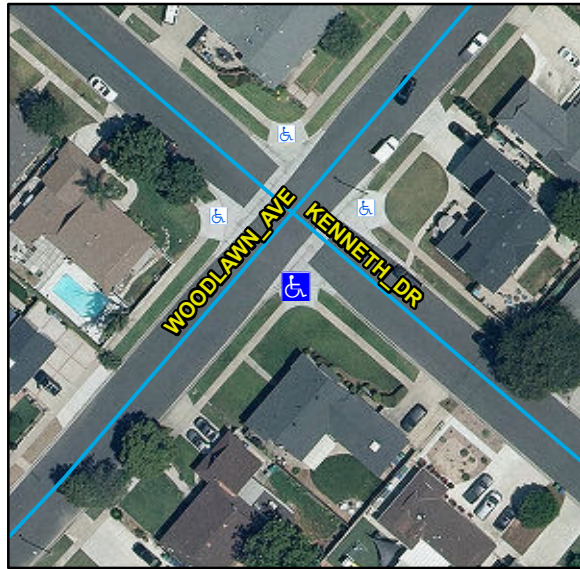
| Compliance | Description | Data | Compliance | Description | Data |
|---|---|---|---|---|---|
| N/A | Landing Movement Obstructed? | Yes | Yes | DWS Contrast | Yes |
| | Landing Movement Type | Curb | Yes | DWS Length (in) | 36 |

Remove & Replace Landing.

R304.2.1, STD 1115

Total Cost: \$ 531
