# Access Compliance Report Public Rights-of-Way (Curb Ramps)

Main Street: IRVINE\_BLVD Cross Street: HOLT\_AVE Location: SE

ADA ID: RPRK220121113459 Ramp Type: Type 1 - Perpendicular Diagonal Initial Pass/Fail: Pass Overall Compliance: No Severity Score: 9

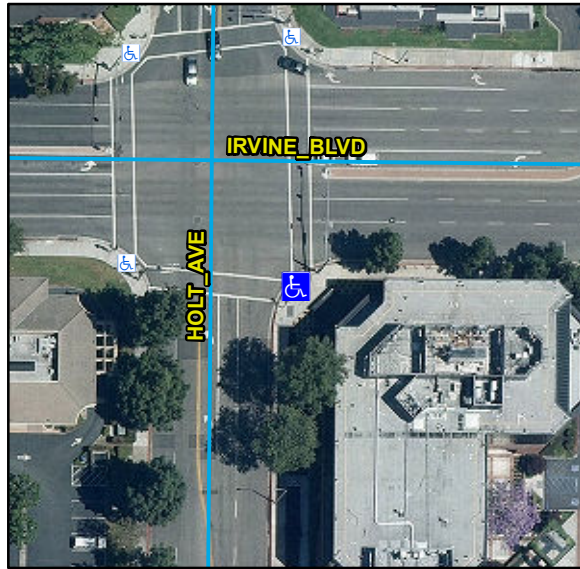
| Compliance | Description | Data | Compliance | Description | Data |
|---|---|---|---|---|---|
| No | Gutter Run Slope (%) | 6.8 | | Road Cross Slope (%) | 4.4 |

Remove & Replace Landing. Remove & Replace Gutter.

R304.2.1, R304.5.4, STD 1115
