# Access Compliance Report Public Rights-of-Way (Curb Ramps)

Main Street: PLAZA\_WY Cross Street: HOLT\_AVE Location: SE

ADA ID: RPRK220121115801 Ramp Type: Type 4 - Parallel Initial Pass/Fail: Fail Overall Compliance: No Severity Score: 2

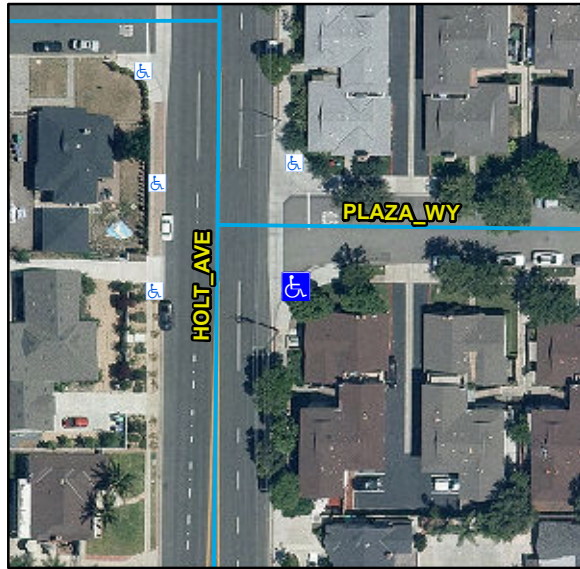
| Compliance | Description | Data | Compliance | Description | Data |
|---|---|---|---|---|---|
| No | Ramp Cross Slope LT (%) | 2.7 | Yes | Ramp Cross Slope RT (%) | 1 |

Remove & Replace Curb Ramp With Two New Directional Ramps or Equivalent.

R304.5.3, STD 1115
