# Access Compliance Report Public Rights-of-Way (Curb Ramps)

Main Street: LEON\_WAY Cross Street: HOLT\_AVE Location: NW

ADA ID: RPRK220121120726 Ramp Type: Type 4 - Parallel Initial Pass/Fail: Fail Overall Compliance: No Severity Score: 15

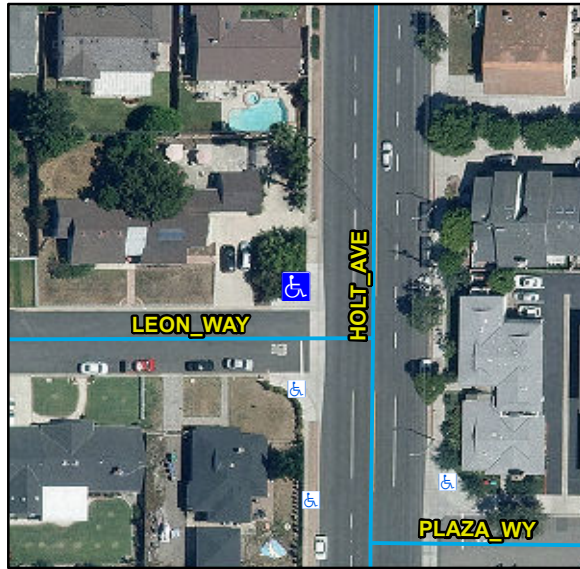
| Compliance | Description | Data | Compliance | Description | Data |
|---|---|---|---|---|---|
| Yes | Ramp Run Slope LT (%) | 6.1 | No | Ramp Run Slope RT (%) | 8.7 |

**Remove & Replace Curb Ramp With Two New Directional Ramps or Equivalent.**

**R304.3.2, STD 1115**
