# Access Compliance Report Public Rights-of-Way (Curb Ramps)

Main Street: HOLT\_AVE Cross Street: BENETA\_WAY Location: SW

ADA ID: RPRK220121121021 Ramp Type: Type 4 - Parallel Initial Pass/Fail: Fail Overall Compliance: No Severity Score: 16

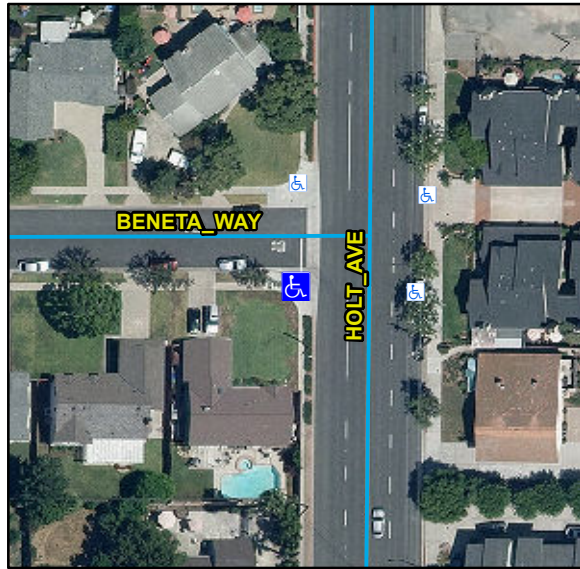
| Compliance | Description | Data | Compliance | Description | Data |
|---|---|---|---|---|---|
| Yes | Ramp Run Slope LT (%) | 3.2 | No | Ramp Run Slope RT (%) | 8.5 |
| No | Ramp Cross Slope LT (%) | 2.8 | Yes | Ramp Cross Slope RT (%) | 0.8 |

**Remove & Replace Curb Ramp With Two New Directional Ramps or Equivalent.**

**R304.5.3, R304.3.2, STD 1115**

Total Cost: \$ 4000
