# Access Compliance Report Public Rights-of-Way (Curb Ramps)

Main Street: **HOLT\_AVE** Cross Street: **LUCERO\_WAY** Location: **SW**

ADA ID: **RPRK220121121602** Ramp Type: **Type 4 - Parallel** Initial Pass/Fail: **Fail** Overall Compliance: **No** Severity Score: **2**

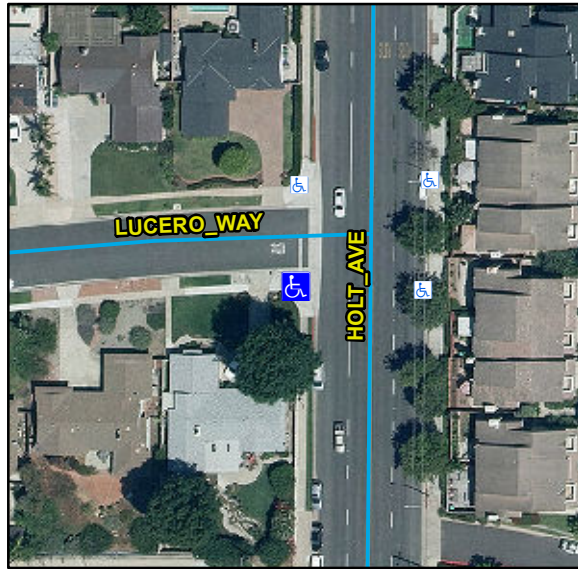
| Compliance | Description | Data | Compliance | Description | Data |
|---|---|---|---|---|---|
| <b>No</b> | Ramp Cross Slope LT (%) | <b>2.4</b> | <b>No</b> | Ramp Cross Slope RT (%) | <b>2.3</b> |

**Remove & Replace Curb Ramp With Two New Directional Ramps or Equivalent.**
