# Access Compliance Report Public Rights-of-Way (Curb Ramps)

Main Street: LUCERO\_WAY Cross Street: HOLT\_AVE Location: NW

ADA ID: RPRK220121122159 Ramp Type: Type 4 - Parallel Initial Pass/Fail: Fail Overall Compliance: No Severity Score: 2

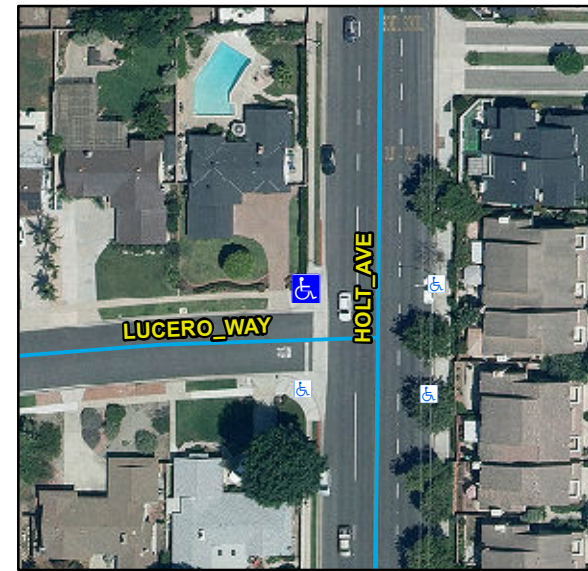
| Compliance | Description | Data | Compliance | Description | Data |
|---|---|---|---|---|---|
| Yes | Ramp Cross Slope LT (%) | 1.2 | No | Ramp Cross Slope RT (%) | 3.8 |

Remove & Replace Curb Ramp With Two New Directional Ramps or Equivalent.

R304.5.3, STD 1115
