Access Compliance Report Public Rights-of-Way (Curb Ramps)

Main Street: THEODORA_DR **Cross Street:** HOLT_AVE **Location:** NW

ADA ID: RPRK220121122509 **Ramp Type:** Type 4 - Parallel **Initial Pass/Fail:** Fail **Overall Compliance:** No **Severity Score:** 2

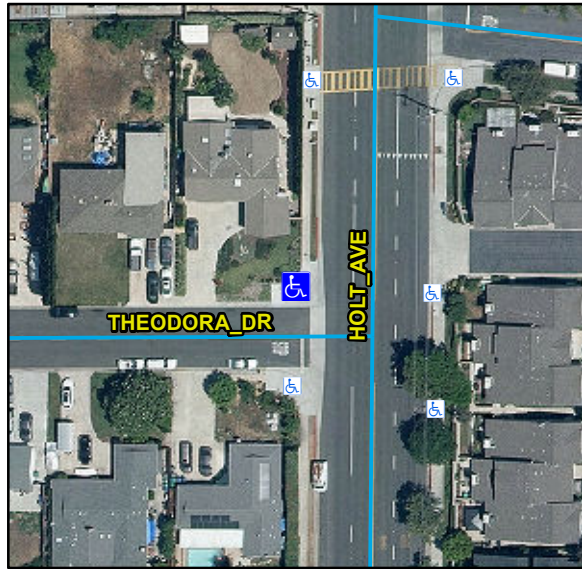
Compliance	Description	Data	Compliance	Description	Data
N/A	Ramp Length LT (in)	89	N/A	Ramp Length RT (in)	90
Yes	Ramp Width LT (in)	102	Yes	Ramp Width RT (in)	102
Yes	Ramp Run Slope LT (%)	4.8	Yes	Ramp Run Slope RT (%)	4.2
No	Ramp Cross Slope LT (%)	2.5	No	Ramp Cross Slope RT (%)	3.7
N/A	Landing Present	N/A	N/A	DWS Provided	N/A
N/A	Landing Length (in)	N/A	N/A	DWS Contrast	N/A
N/A	Landing Width (in)	N/A	N/A	DWS Length (in)	N/A
N/A	Landing Run Slope (%)	N/A	N/A	DWS Full Width	N/A
N/A	Landing Cross Slope (%)	N/A		DWS Offset Type	N/A
N/A	Landing Movement Obstructed?	N/A	N/A	DWS Offset Left (in)	N/A
	Landing Movement Type	N/A	N/A	DWS Offset Right (in)	N/A
N/A	Landing Shared	N/A			
N/A	Clear Space	Yes			
N/A	Clear Space To Crosswalk (in)	N/A			
N/A	Marked Crosswalk 1	No	N/A	Marked Crosswalk 2	No
	Crossing 1 Direction	S		Crossing 2 Direction	E
N/A	Marked Crosswalk 1 Width (in)	N/A	N/A	Marked Crosswalk 2 Width (in)	N/A

N/A	Ramp Inside Crosswalk 1	N/A	N/A	Ramp Inside Crosswalk 2	N/A
	Crossing 1 Slope (%)	3.3		Crossing 2 Slope (%)	8.1
	Crossing 1 Cross Slope (%)	3.3		Crossing 2 Cross Slope (%)	0.7
N/A	Gutter Ponding	N/A	Yes	Curb Slope	6.3
Yes	Gutter Lip Height (in)	0		Road Run Slope (%)	0.8
N/A	Gutter Run Slope (%)	N/A		Road Cross Slope (%)	3
N/A	Gutter Cross Slope (%)	N/A	Yes	Perpendicular Joint Present	Yes
Yes	Overall Surface Condition	Acceptable			
	Cross Gutter Present?	Yes		Spandrel Present?	Yes
	Replace Cross Gutter?	No		Replace Spandrel?	No

Possible Solutions:
Remove & Replace Curb Ramp With Two New Directional Ramps or Equivalent.

OC Std/PROW:
 R304.5.3, STD 1115

Total Cost: \$ 4000
