# Access Compliance Report Public Rights-of-Way (Curb Ramps)

| Main Street: HOLT_AVE | | Cross Street: WARREN_AVE | | Location: | SW |
| ADA ID: RPRK220121122751 | Ramp Type: Type 4 - Parallel | Initial Pass/Fail: Fail | Overall Compliance: No | Severity Score: | 15 |

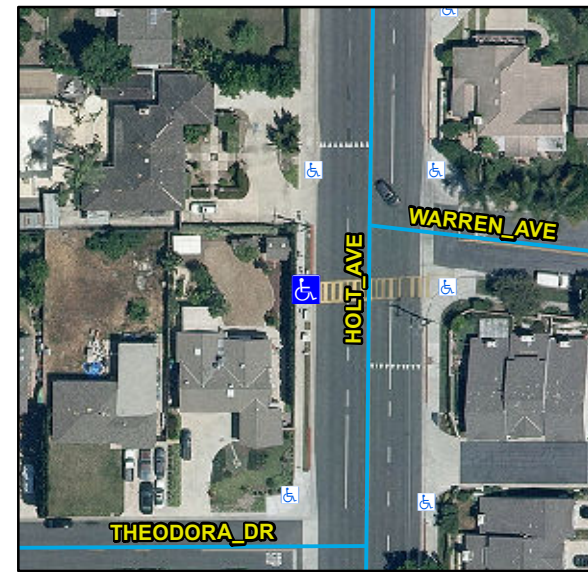
| Compliance | Description | Data | Compliance | Description | Data |
|---|---|---|---|---|---|
| No | Ramp Cross Slope LT (%) | 2.9 | No | Ramp Cross Slope RT (%) | 6 |

Possible Solutions:

**Remove & Replace Entire Ramp.**

**R304.5.3, STD 1115**

Total Cost: \$ 2000
