# Access Compliance Report Public Rights-of-Way (Curb Ramps)

Main Street: WARREN\_AVE Cross Street: CLARISSA\_LN Location: NW

ADA ID: RPRK220121123419 Ramp Type: Type 4 - Parallel Initial Pass/Fail: Fail Overall Compliance: No Severity Score: 2

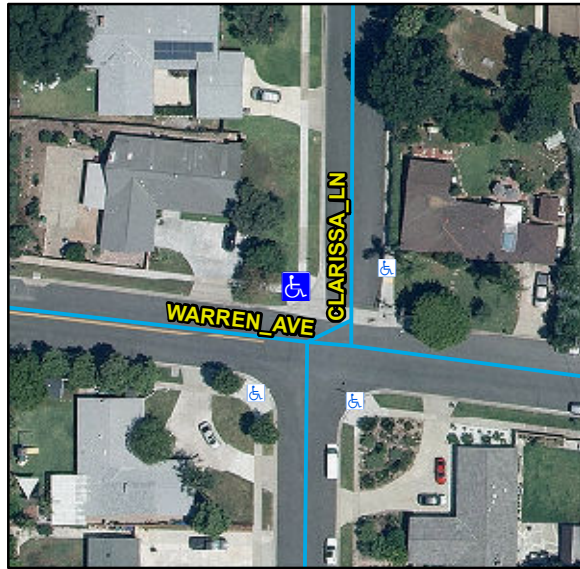
| Compliance | Description | Data | Compliance | Description | Data |
|---|---|---|---|---|---|
| No | Ramp Cross Slope LT (%) | 2.9 | No | Ramp Cross Slope RT (%) | 3.6 |

**Remove & Replace Curb Ramp With Two New Directional Ramps or Equivalent.**

**R304.5.3, STD 1115**
