# Access Compliance Report Public Rights-of-Way (Curb Ramps)

Main Street: WARREN\_AVE Cross Street: CLARISSA\_LN Location: SE

ADA ID: RPRK220121123657 Ramp Type: Type 4 - Parallel Initial Pass/Fail: Fail Overall Compliance: No Severity Score: 2

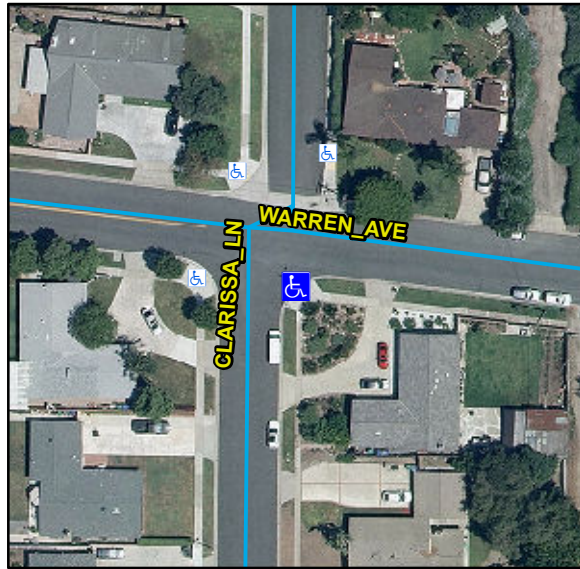
| Compliance | Description | Data | Compliance | Description | Data |
|---|---|---|---|---|---|
| Yes | Ramp Run Slope LT (%) | 6.4 | Yes | Ramp Run Slope RT (%) | 1.3 |
| No | Ramp Cross Slope LT (%) | 2.6 | No | Ramp Cross Slope RT (%) | 2.1 |

Remove & Replace Curb Ramp With Two New Directional Ramps or Equivalent.

R304.5.3, STD 1115
