# Access Compliance Report Public Rights-of-Way (Curb Ramps)

Main Street: N/A Cross Street: EHLEN\_WAY Location: NW

ADA ID: RPRK220121124612 Ramp Type: Type 7 - Directional 2 Initial Pass/Fail: Fail Overall Compliance: No Severity Score: 30

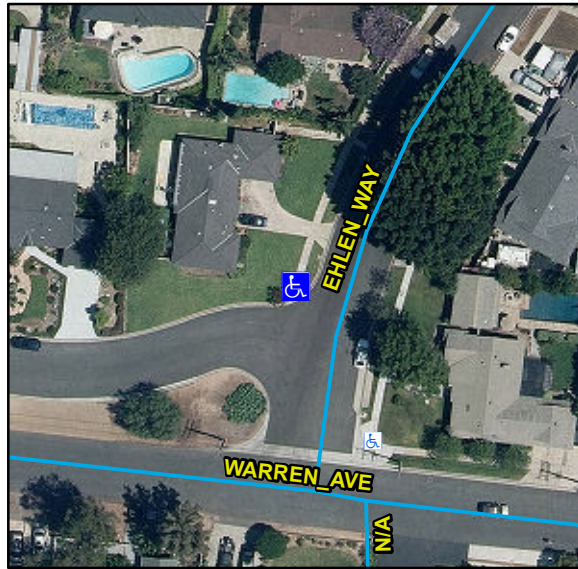
R204.3, R304.2.2, STD 1115

| Compliance | Description | Data | Compliance | Description | Data |
|---|---|---|---|---|---|
| No | Ramp Run Slope (%) | 12.1 | N/A | Flare Slope LT (%) | N/A |

Remove & Replace Entire Ramp.
