# Access Compliance Report Public Rights-of-Way (Curb Ramps)

Main Street: LIVINGSTON\_AVE Cross Street: NORWOOD\_PKWY Location: NE

ADA ID: RPRK220121130928 Ramp Type: Type 4 - Parallel Initial Pass/Fail: Fail Overall Compliance: No Severity Score: 2

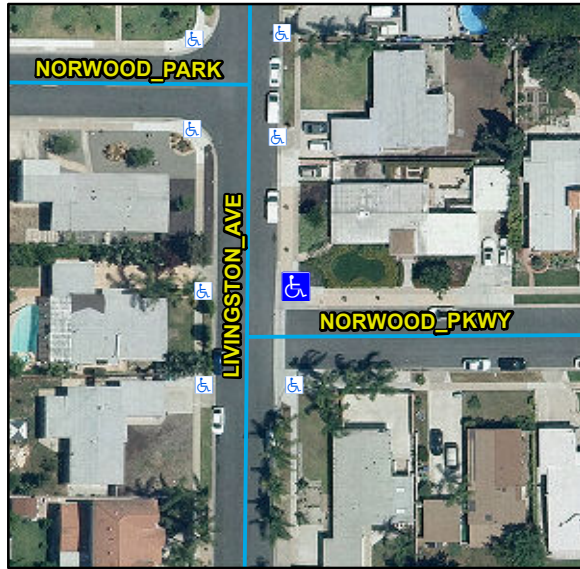
| Compliance | Description | Data | Compliance | Description | Data |
|---|---|---|---|---|---|
| No | Ramp Cross Slope LT (%) | 3 | Yes | Ramp Cross Slope RT (%) | 0.7 |

Remove & Replace Curb Ramp With Two New Directional Ramps or Equivalent.

R304.5.3, STD 1115
