# Access Compliance Report Public Rights-of-Way (Curb Ramps)

Main Street: NORWOOD\_PKWY Cross Street: DALL\_LN Location: SE

ADA ID: RPRK220121131546 Ramp Type: Type 4 - Parallel Initial Pass/Fail: Fail Overall Compliance: No Severity Score: 2

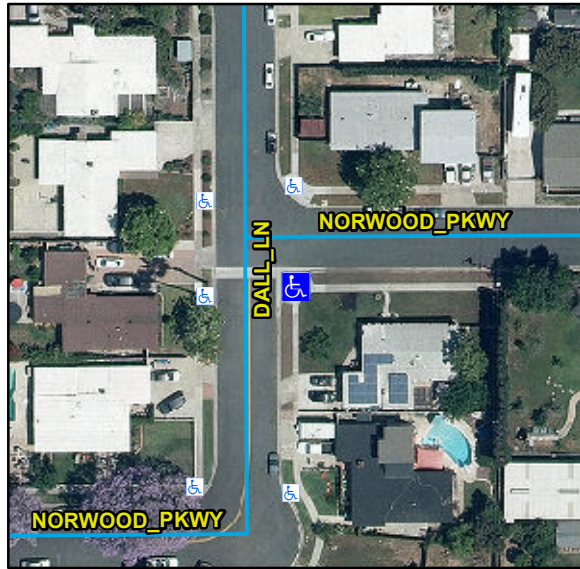
| Compliance | Description | Data | Compliance | Description | Data |
|---|---|---|---|---|---|
| No | Ramp Cross Slope LT (%) | 3.5 | Yes | Ramp Cross Slope RT (%) | 0.7 |

**Remove & Replace Curb Ramp With Two New Directional Ramps or Equivalent.**

**R304.5.3, STD 1115**
