# Access Compliance Report Public Rights-of-Way (Curb Ramps)

Main Street: DALL\_LN Cross Street: NORWOOD\_PKWY Location: NE

ADA ID: RPRK220121131813 Ramp Type: Type 4 - Parallel Initial Pass/Fail: Fail Overall Compliance: No Severity Score: 15

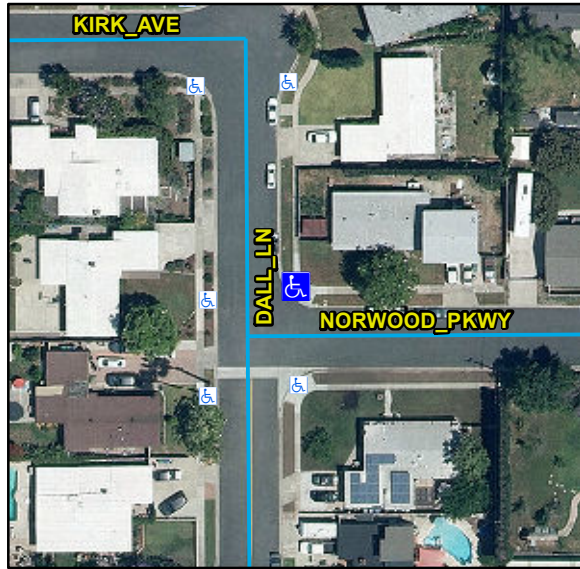
| Compliance | Description | Data | Compliance | Description | Data |
|---|---|---|---|---|---|
| No | Ramp Cross Slope LT (%) | 5.3 | No | Ramp Cross Slope RT (%) | 4.2 |

**Remove & Replace Curb Ramp With Two New Directional Ramps or Equivalent.**

**R304.5.3, STD 1115**
