# Access Compliance Report Public Rights-of-Way (Curb Ramps)

Main Street: NORWOOD\_PARK Cross Street: LIVINGSTON\_AVE Location: NW

ADA ID: RPRK220121132151 Ramp Type: Type 4 - Parallel Initial Pass/Fail: Pass Overall Compliance: No Severity Score: 0

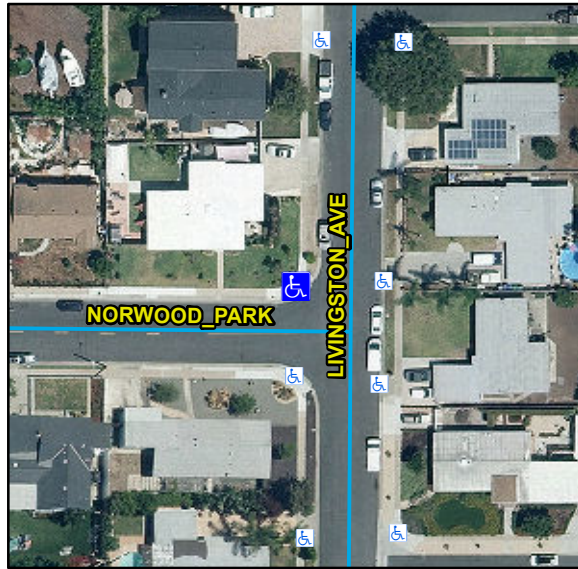
Gutter Ponding Observed.

| Compliance | Description | Data | Compliance | Description | Data |
|---|---|---|---|---|---|
| No | Gutter Ponding | Yes | Yes | Curb Slope | 1.9 |

R302.7, STD 1115

Total Cost: \$ 252
