# Access Compliance Report Public Rights-of-Way (Curb Ramps)

Main Street: LIVINGSTON\_AVE Cross Street: NORWOOD\_PARK Location: SW

ADA ID: RPRK220121132759 Ramp Type: Type 4 - Parallel Initial Pass/Fail: Fail Overall Compliance: No Severity Score: 2

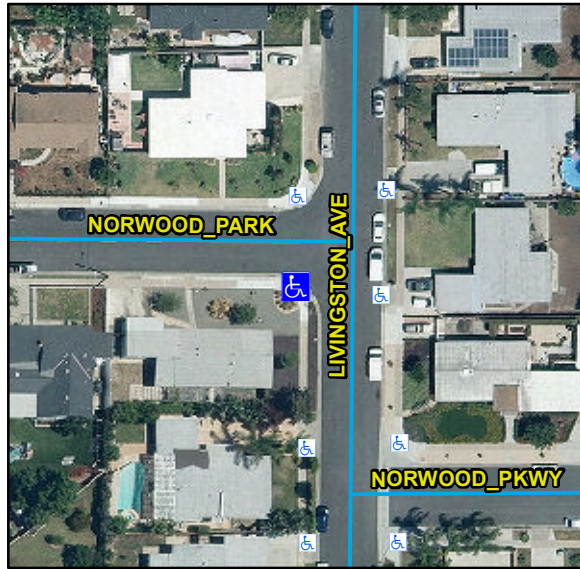
| Compliance | Description | Data | Compliance | Description | Data |
|---|---|---|---|---|---|
| Yes | Ramp Cross Slope LT (%) | 1.9 | No | Ramp Cross Slope RT (%) | 4.3 |

**Remove & Replace Curb Ramp With Two New Directional Ramps or Equivalent.**

R304.5.3, STD 1115
