# Access Compliance Report Public Rights-of-Way (Curb Ramps)

Main Street: PROSPECT\_AVE Cross Street: AMAGANSET\_WAY Location: SW

ADA ID: RPRK220121133411 Ramp Type: Type 4 - Parallel Initial Pass/Fail: Fail Overall Compliance: No Severity Score: 2

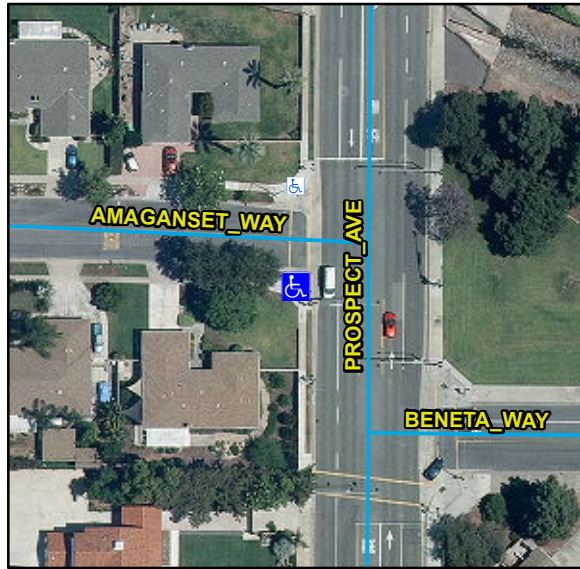
| Compliance | Description | Data | Compliance | Description | Data |
|---|---|---|---|---|---|
| No | Ramp Cross Slope LT (%) | 3.6 | Yes | Ramp Cross Slope RT (%) | 0.1 |

Remove & Replace Curb Ramp With Two New Directional Ramps or Equivalent.

R304.5.3, STD 1115
