# Access Compliance Report Public Rights-of-Way (Curb Ramps)

Main Street: AMAGANSET\_WAY Cross Street: PROSPECT\_AVE Location: NW

ADA ID: RPRK220121133833 Ramp Type: Type 4 - Parallel Initial Pass/Fail: Fail Overall Compliance: No Severity Score: 2

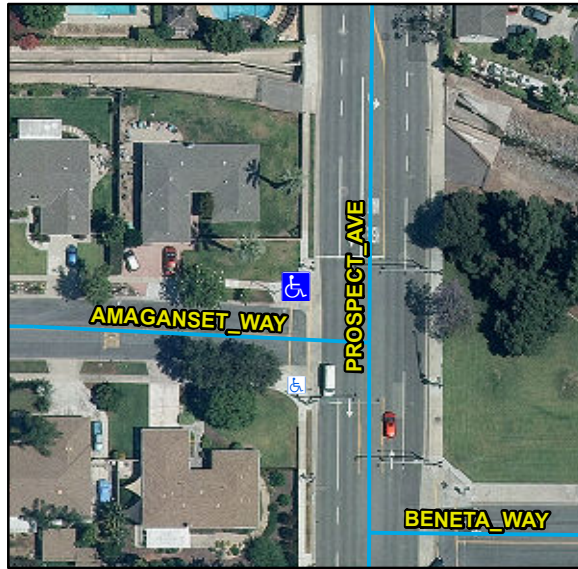
| Compliance | Description | Data | Compliance | Description | Data |
|---|---|---|---|---|---|
| No | Ramp Cross Slope LT (%) | 3.1 | Yes | Ramp Cross Slope RT (%) | 1.3 |

**Remove & Replace Curb Ramp With Two New Directional Ramps or Equivalent.**

**R304.5.3, STD 1115**

Total Cost: \$ 4000
