# Access Compliance Report Public Rights-of-Way (Curb Ramps)

Main Street: SHERBROOK\_DR Cross Street: PROSPECT\_AVE Location: NW

ADA ID: RPRK220121134322 Ramp Type: Type 4 - Parallel Initial Pass/Fail: Fail Overall Compliance: No Severity Score: 2

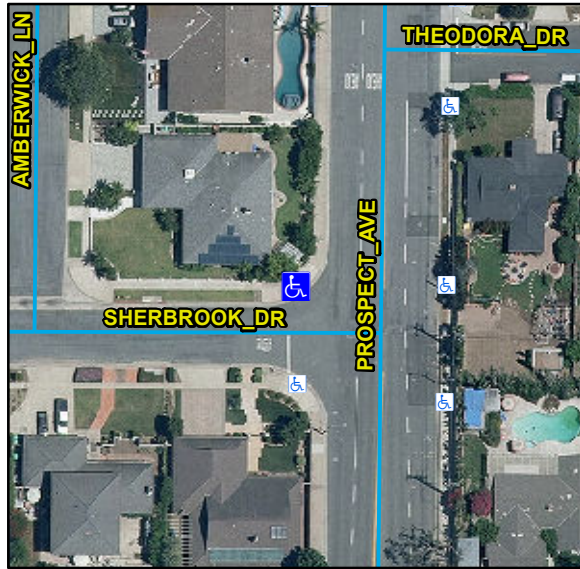
| Compliance | Description | Data | Compliance | Description | Data |
|---|---|---|---|---|---|
| Yes | Ramp Cross Slope LT (%) | 1.5 | No | Ramp Cross Slope RT (%) | 4.4 |

Remove & Replace Curb Ramp With Two New Directional Ramps or Equivalent.

R204.3, R304.5.3, STD 1115

Total Cost: \$ 4000
