# Access Compliance Report Public Rights-of-Way (Curb Ramps)

Main Street: PROSPECT\_AVE Cross Street: SHERBROOK\_DR Location: SW

ADA ID: RPRK220121134538 Ramp Type: Type 4 - Parallel Initial Pass/Fail: Fail Overall Compliance: No Severity Score: 15

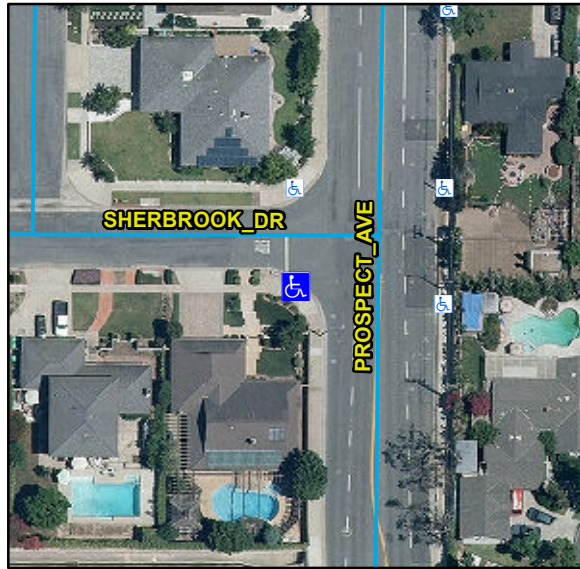
| Compliance | Description | Data | Compliance | Description | Data |
|---|---|---|---|---|---|
| No | Ramp Cross Slope LT (%) | 6.3 | No | Ramp Cross Slope RT (%) | 6.2 |
| No | Gutter Lip Height (in) | 0.25 | | Road Run Slope (%) | 0.2 |

**Remove & Replace Curb Ramp With Two New Directional Ramps or Equivalent. Grind Gutter Lip.**

**R204.3, R304.5.3, R302.7.2, STD 1115**
