# Access Compliance Report Public Rights-of-Way (Curb Ramps)

| Main Street: PROSPECT_AVE | | Cross Street: THEODORA_DR | | Location: | NE |
| ADA ID: RPRK220121135059 | Ramp Type: Type 4 - Parallel | Initial Pass/Fail: Fail | Overall Compliance: No | Severity Score: | 15 |

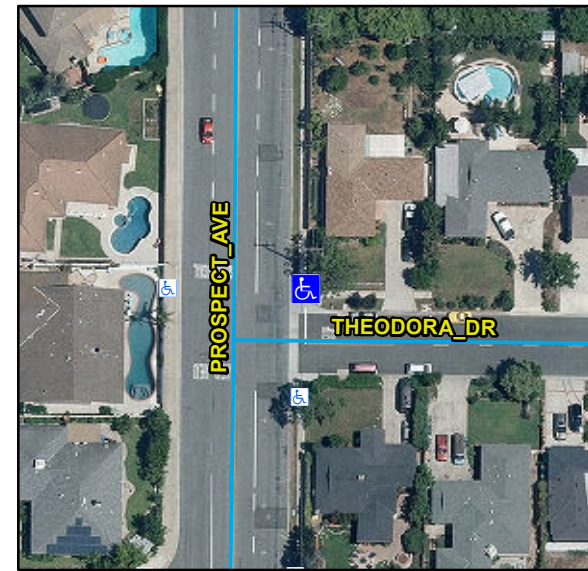
| Compliance | Description | Data | Compliance | Description | Data |
|---|---|---|---|---|---|
| No | Ramp Cross Slope LT (%) | 5.4 | No | Ramp Cross Slope RT (%) | 3.5 |

**Remove & Replace Curb Ramp With Two New Directional Ramps or Equivalent.**

**R304.5.3, STD 1115**

Total Cost: \$ 4000
