# Access Compliance Report Public Rights-of-Way (Curb Ramps)

Main Street: PROSPECT\_AVE Cross Street: ORANGE\_TREE\_LN Location: SW

ADA ID: RPRK220121140606 Ramp Type: Type 4 - Parallel Initial Pass/Fail: Fail Overall Compliance: No Severity Score: 2

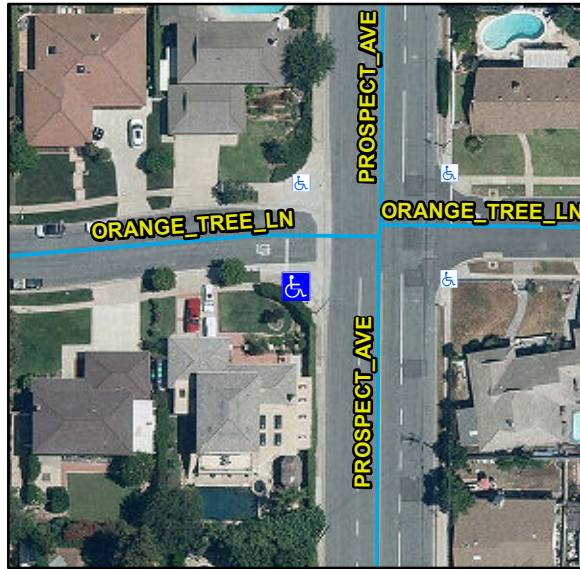
| Compliance | Description | Data | Compliance | Description | Data |
|---|---|---|---|---|---|
| Yes | Ramp Cross Slope LT (%) | 0.6 | No | Ramp Cross Slope RT (%) | 2.8 |
| N/A | Gutter Cross Slope (%) | N/A | No | Perpendicular Joint Present | No |

Remove & Replace Curb Ramp With Two New Directional Ramps or Equivalent.

R204.3, R304.5.3, STD 1115
