# Access Compliance Report Public Rights-of-Way (Curb Ramps)

| Main Street: ORANGE_TREE_LN | | Cross Street: PROSPECT_AVE | | Location: | NW |
| ADA ID: RPRK220121140819 | Ramp Type: Type 4 - Parallel | Initial Pass/Fail: Fail | Overall Compliance: No | Severity Score: | 15 |

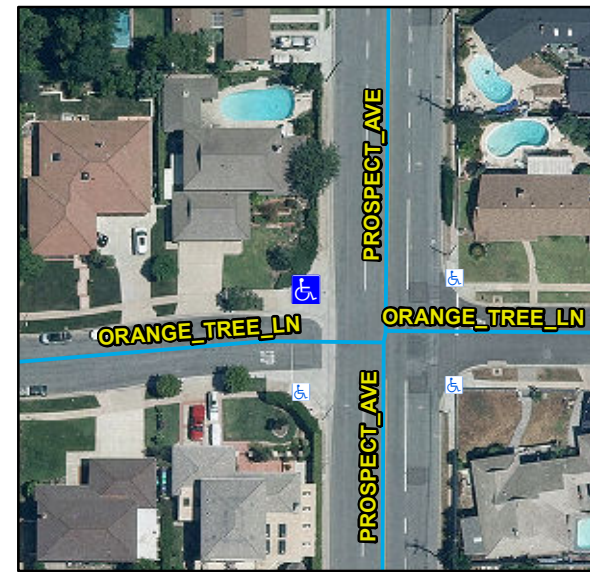
| Compliance | Description | Data | Compliance | Description | Data |
|---|---|---|---|---|---|
| No | Ramp Cross Slope LT (%) | 5.9 | No | Ramp Cross Slope RT (%) | 6 |

**Remove & Replace Curb Ramp With Two New Directional Ramps or Equivalent.**

**R204.3, R304.5.3, STD 1115**

Total Cost: \$ 4000
