# Access Compliance Report Public Rights-of-Way (Curb Ramps)

Main Street: PROSPECT\_AVE Cross Street: ORANGE\_TREE\_LN Location: NE

ADA ID: RPRK220121141050 Ramp Type: Type 4 - Parallel Initial Pass/Fail: Fail Overall Compliance: No Severity Score: 16

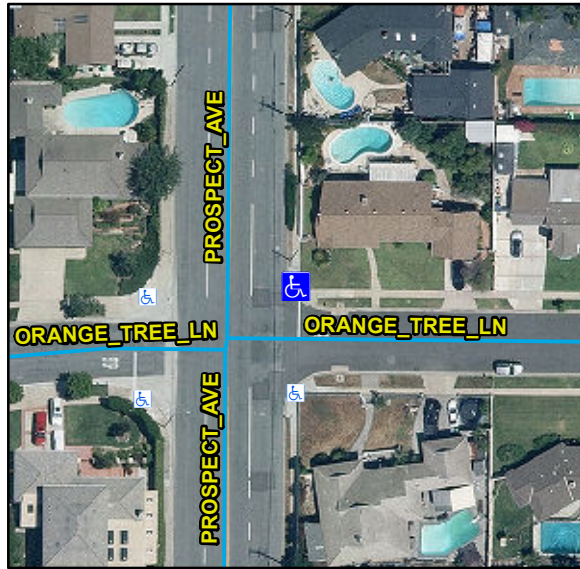
| Compliance | Description | Data | Compliance | Description | Data |
|---|---|---|---|---|---|
| No | Ramp Run Slope LT (%) | 10.5 | Yes | Ramp Run Slope RT (%) | 5.7 |
| No | Ramp Cross Slope LT (%) | 3.1 | No | Ramp Cross Slope RT (%) | 2.2 |

Remove & Replace Curb Ramp With Two New Directional Ramps or Equivalent.

R204.3, R304.3.2, R304.5.3, STD 1115
