# Access Compliance Report Public Rights-of-Way (Curb Ramps)

| Main Street: PROSPECT_AVE | | Cross Street: WELLINGTON_AVE | | Location: | SW |
| ADA ID: RPRK220121142159 | Ramp Type: Type 4 - Parallel | Initial Pass/Fail: Fail | Overall Compliance: No | Severity Score: | 2 |

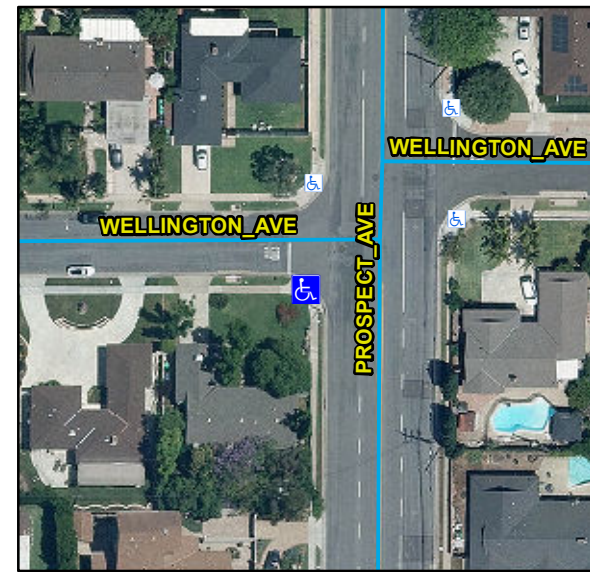
| Compliance | Description | Data | Compliance | Description | Data |
|---|---|---|---|---|---|
| No | Ramp Cross Slope LT (%) | 3.3 | Yes | Ramp Cross Slope RT (%) | 1.1 |

**Remove & Replace Curb Ramp With Two New Directional Ramps or Equivalent.**
