# Access Compliance Report Public Rights-of-Way (Curb Ramps)

Main Street: WELLINGTON\_AVE Cross Street: PROSPECT\_AVE Location: NW

ADA ID: RPRK220121142502 Ramp Type: Type 4 - Parallel Initial Pass/Fail: Pass Overall Compliance: No Severity Score: 25

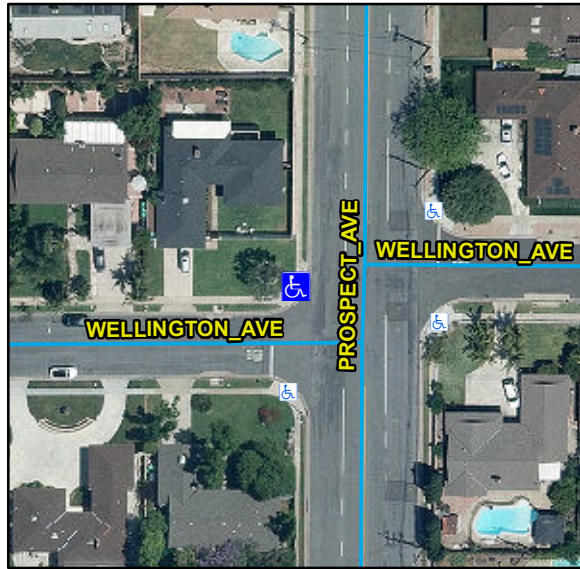
| Compliance | Description | Data | Compliance | Description | Data |
|---|---|---|---|---|---|
| N/A | Landing Present | No | No | DWS Provided | No |
| No | Landing Width (in) | N/A | N/A | DWS Length (in) | N/A |
| No | Landing Run Slope (%) | N/A | N/A | DWS Full Width | N/A |
| No | Landing Cross Slope (%) | N/A | | DWS Offset Type | N/A |
| Yes | Gutter Ponding | No | No | Curb Slope | 9.2 |
| No | Gutter Lip Height (in) | 0.25 | | Road Run Slope (%) | 2.5 |
| No | Gutter Run Slope (%) | 7.1 | | Road Cross Slope (%) | 5.9 |
| No | Gutter Cross Slope (%) | 2.9 | No | Perpendicular Joint Present | No |

Remove & Replace Curb Ramp With Two New Directional Ramps or Equivalent. Remove & Replace Gutter.
