# Access Compliance Report Public Rights-of-Way (Curb Ramps)

Main Street: PROSPECT\_AVE Cross Street: WELLINGTON\_AVE Location: NE

ADA ID: RPRK220121142757 Ramp Type: Type 4 - Parallel Initial Pass/Fail: Fail Overall Compliance: No Severity Score: 2

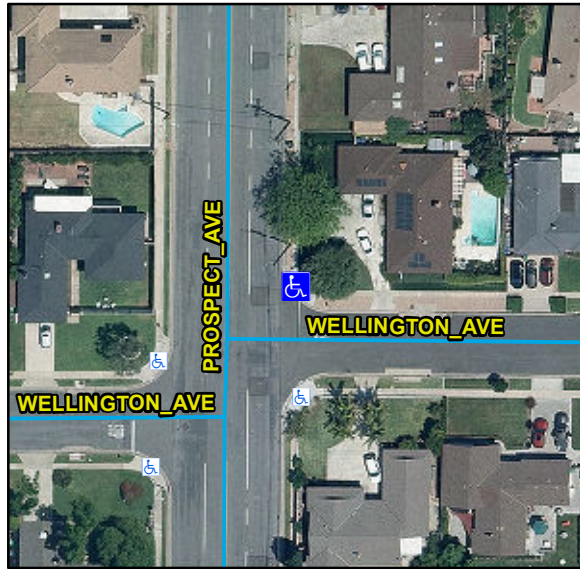
| Compliance | Description | Data | Compliance | Description | Data |
|---|---|---|---|---|---|
| Yes | Ramp Cross Slope LT (%) | 1 | No | Ramp Cross Slope RT (%) | 2.7 |

**Remove & Replace Curb Ramp With Two New Directional Ramps or Equivalent.**

**R304.5.3, STD 1115**
