# Access Compliance Report Public Rights-of-Way (Curb Ramps)

Main Street: WELLINGTON\_AVE Cross Street: HOWLAND\_WAY Location: NW

ADA ID: RPRK220121143114 Ramp Type: Type 4 - Parallel Initial Pass/Fail: Fail Overall Compliance: No Severity Score: 2

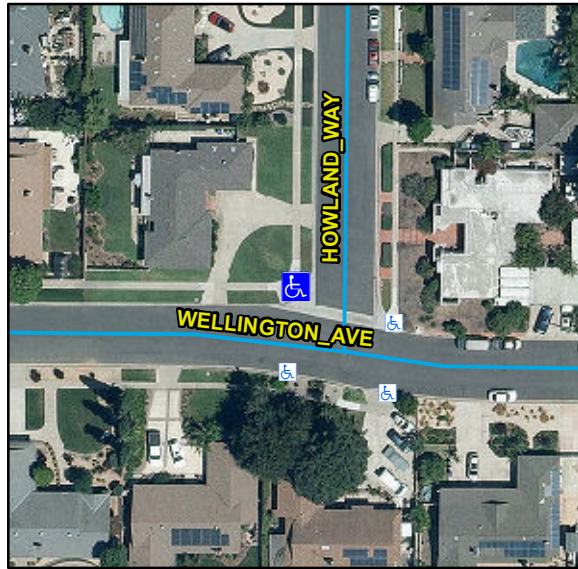
| Compliance | Description | Data | Compliance | Description | Data |
|---|---|---|---|---|---|
| Yes | Ramp Run Slope LT (%) | 3.9 | Yes | Ramp Run Slope RT (%) | 6.2 |
| No | Ramp Cross Slope LT (%) | 2.4 | No | Ramp Cross Slope RT (%) | 3.3 |

**Remove & Replace Curb Ramp With Two New Directional Ramps or Equivalent.**

**R304.5.3, STD 1115**

Total Cost: \$ 4000
