# Access Compliance Report Public Rights-of-Way (Curb Ramps)

Main Street: 17TH\_ST Cross Street: PROSPECT\_AVE Location: NW

ADA ID: RPRK220124103617 Ramp Type: Type 1 - Perpendicular Diagonal Initial Pass/Fail: Fail Overall Compliance: No Severity Score: 15

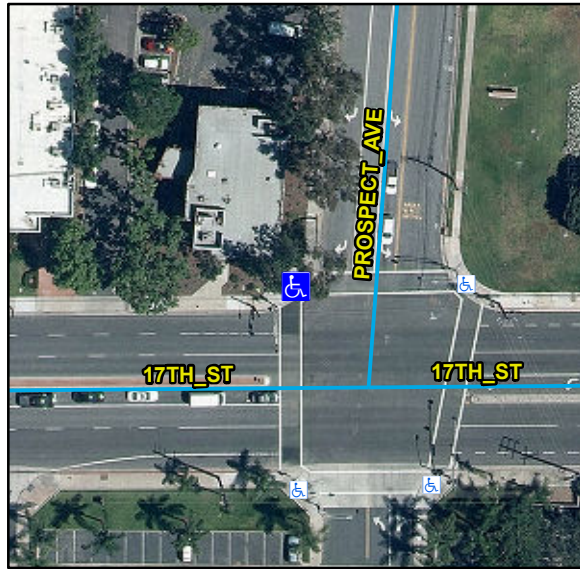
| Compliance | Description | Data | Compliance | Description | Data |
|---|---|---|---|---|---|
| No | Ramp Run Slope (%) | 8.7 | N/A | Flare Slope LT (%) | N/A |

Remove & Replace Curb Ramp With Two New Directional Ramps or Equivalent.

R304.2.2, STD 1115
