# Access Compliance Report Public Rights-of-Way (Curb Ramps)

Main Street: 17TH\_ST Cross Street: PROSPECT\_AVE Location: S

ADA ID: RPRK220124104805 Ramp Type: Type 1 - Perpendicular Diagonal Initial Pass/Fail: Fail Overall Compliance: No Severity Score: 2

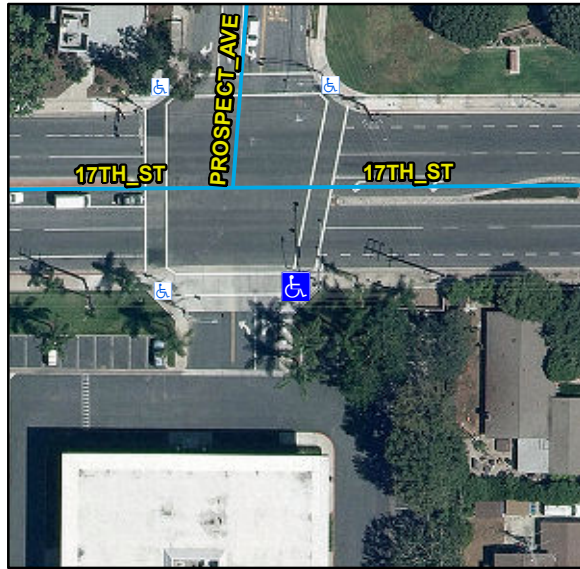
| Compliance | Description | Data | Compliance | Description | Data |
|---|---|---|---|---|---|
| No | Ramp Cross Slope (%) | 2.5 | N/A | Flare Traversable LT | N/A |

Remove & Replace Curb Ramp With Two New Directional Ramps or Equivalent. Restripe Crosswalk.

R304.5.3, STD 1115
