# Access Compliance Report Public Rights-of-Way (Curb Ramps)

Main Street: LAMBETH\_WAY Cross Street: 17TH\_ST Location: SW

ADA ID: RPRK220124110309 Ramp Type: Type 4 - Parallel Initial Pass/Fail: Fail Overall Compliance: No Severity Score: 2

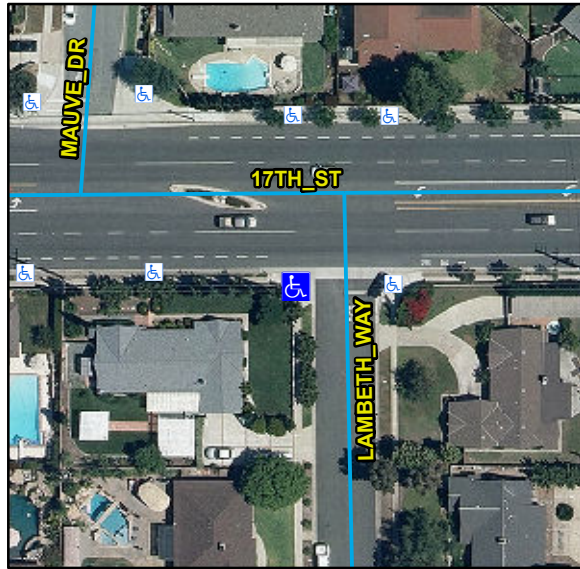
| Compliance | Description | Data | Compliance | Description | Data |
|---|---|---|---|---|---|
| Yes | Ramp Cross Slope LT (%) | 1.2 | No | Ramp Cross Slope RT (%) | 4.9 |

Remove & Replace Curb Ramp With Two New Directional Ramps or Equivalent.

R304.5.3, STD 1115
