# Access Compliance Report Public Rights-of-Way (Curb Ramps)

Main Street: 17TH\_ST Cross Street: LAMBETH\_WAY Location: SE

ADA ID: RPRK220124110534 Ramp Type: Type 4 - Parallel Initial Pass/Fail: Fail Overall Compliance: No Severity Score: 15

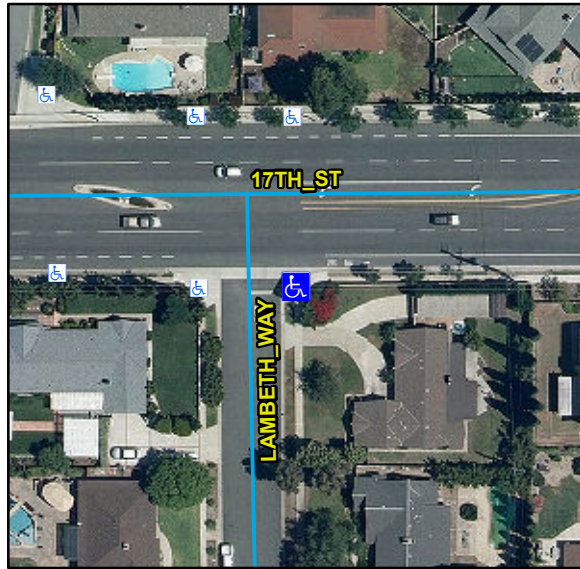
| Compliance | Description | Data | Compliance | Description | Data |
|---|---|---|---|---|---|
| No | Ramp Cross Slope LT (%) | 6.6 | No | Ramp Cross Slope RT (%) | 4.5 |

**Remove & Replace Curb Ramp With Two New Directional Ramps or Equivalent.**

**R304.5.3, STD 1115**

Total Cost: \$ 4000
