# Access Compliance Report Public Rights-of-Way (Curb Ramps)

Main Street: HOLT\_AVE Cross Street: 17TH\_ST Location: NE

ADA ID: RPRK220124111233 Ramp Type: Type 4 - Parallel Initial Pass/Fail: Fail Overall Compliance: No Severity Score: 2

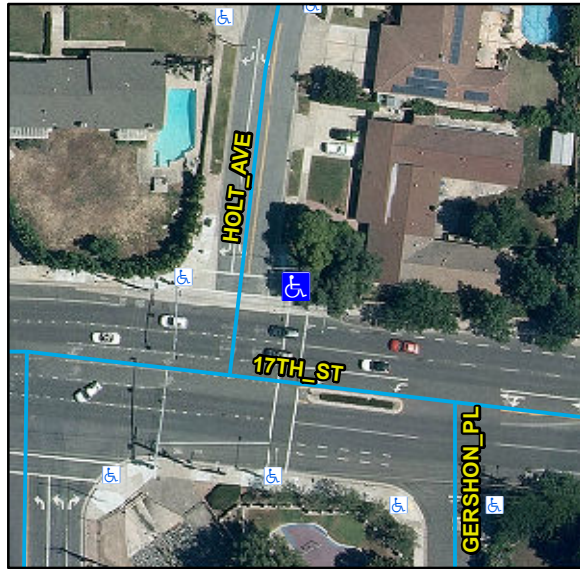
| Compliance | Description | Data | Compliance | Description | Data |
|---|---|---|---|---|---|
| Yes | Ramp Cross Slope LT (%) | 1.9 | No | Ramp Cross Slope RT (%) | 4.5 |
| N/A | Ramp Inside Crosswalk 1 | Yes | N/A | Ramp Inside Crosswalk 2 | No |

Remove & Replace Curb Ramp With Two New Directional Ramps or Equivalent. Restripe Crosswalk.

R304.5.3, STD 1115

\$ 8000
