# Access Compliance Report Public Rights-of-Way (Curb Ramps)

Main Street: HOLT\_AVE Cross Street: 17TH\_ST Location: NW

ADA ID: RPRK220124111601 Ramp Type: Type 4 - Parallel Initial Pass/Fail: Fail Overall Compliance: No Severity Score: 30

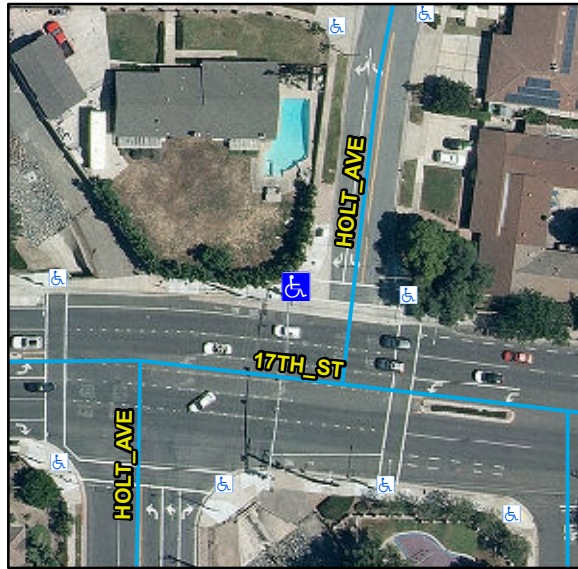
| Compliance | Description | Data | Compliance | Description | Data |
|---|---|---|---|---|---|
| No | Ramp Cross Slope LT (%) | 5.4 | No | Ramp Cross Slope RT (%) | 7.3 |

Remove & Replace Entire Ramp. Restripe Crosswalk.
