# Access Compliance Report Public Rights-of-Way (Curb Ramps)

Main Street: 17TH\_ST Cross Street: DALL\_LN Location: NW

ADA ID: RPRK220124112544 Ramp Type: Type 4 - Parallel Initial Pass/Fail: Fail Overall Compliance: No Severity Score: 2

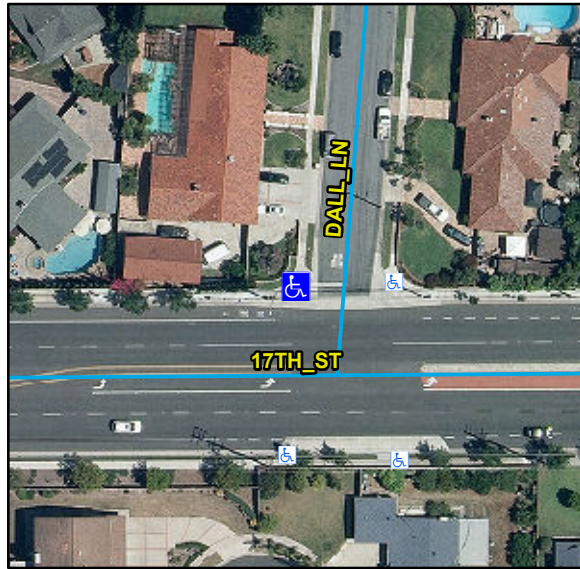
| Compliance | Description | Data | Compliance | Description | Data |
|---|---|---|---|---|---|
| Yes | Ramp Cross Slope LT (%) | 1.9 | No | Ramp Cross Slope RT (%) | 5 |

**Remove & Replace Curb Ramp With Two New Directional Ramps or Equivalent.**

**R304.5.3, STD 1115**
