# Access Compliance Report Public Rights-of-Way (Curb Ramps)

Main Street: IMPALA\_DR Cross Street: HOLT\_AVE Location: NW

ADA ID: RPRK220124114151 Ramp Type: Type 4 - Parallel Initial Pass/Fail: Fail Overall Compliance: No Severity Score: 2

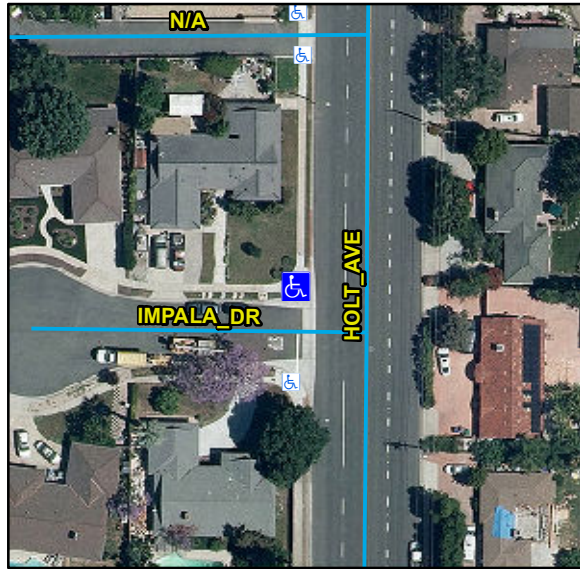
| Compliance | Description | Data | Compliance | Description | Data |
|---|---|---|---|---|---|
| No | Ramp Cross Slope LT (%) | 2.6 | Yes | Ramp Cross Slope RT (%) | 0.7 |

**Remove & Replace Curb Ramp With Two New Directional Ramps or Equivalent.**

**R304.5.3, STD 1115**

Total Cost: \$ 4000
