# Access Compliance Report Public Rights-of-Way (Curb Ramps)

| Main Street: HOLT_AVE | | Cross Street: IMPALA_DR | | Location: | SW |
| ADA ID: RPRK220124114430 | Ramp Type: Type 4 - Parallel | Initial Pass/Fail: Pass | Overall Compliance: No | Severity Score: | 0 |

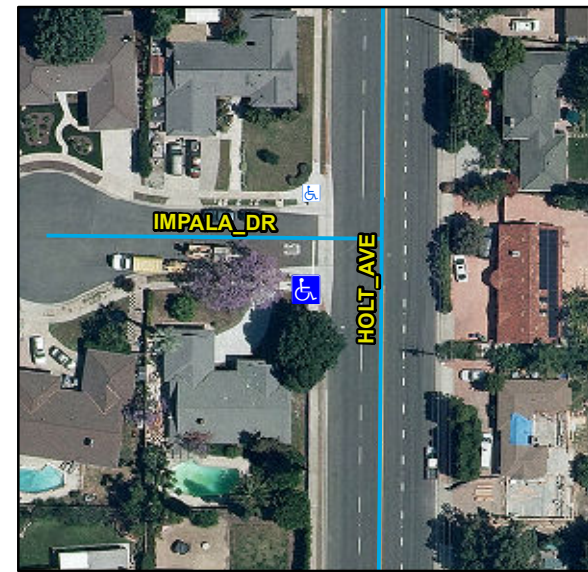
| Compliance | Description | Data | Compliance | Description | Data |
|---|---|---|---|---|---|
| No | Landing Cross Slope (%) | 3.8 | | DWS Offset Type | Single |
| No | Gutter Cross Slope (%) | 2.1 | Yes | Perpendicular Joint Present | Yes |

**Remove & Replace Landing. Remove & Replace Gutter.**

**R304.5.3, STD 1115**
