# Access Compliance Report Public Rights-of-Way (Curb Ramps)

| Main Street: WESTON_PL | | Cross Street: HOLT_AVE | | Location: | NW |
| ADA ID: RPRK220124114751 | Ramp Type: Type 4 - Parallel | Initial Pass/Fail: Fail | Overall Compliance: No | Severity Score: | 15 |

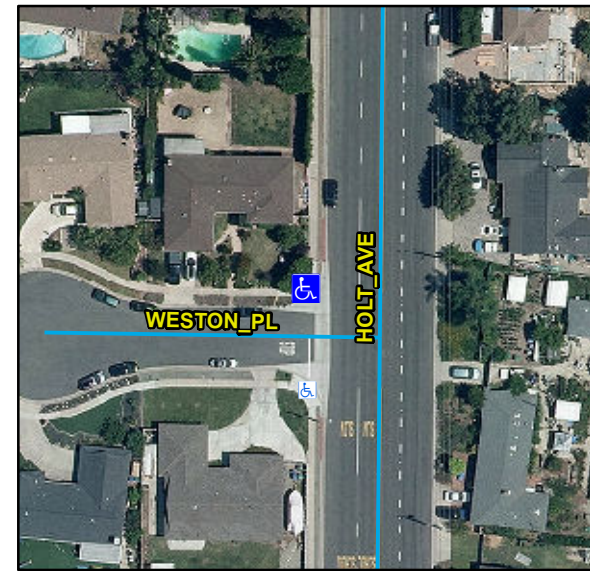
| Compliance | Description | Data | Compliance | Description | Data |
|---|---|---|---|---|---|
| Yes | Ramp Cross Slope LT (%) | 1.3 | No | Ramp Cross Slope RT (%) | 6.2 |

Possible Solutions:

**Remove & Replace Curb Ramp With Two New Directional Ramps or Equivalent.**

**R304.5.3, STD 1115**

Total Cost: \$ 4000
