# Access Compliance Report Public Rights-of-Way (Curb Ramps)

Main Street: VANDERLIP\_PL Cross Street: HOLT\_AVE Location: NW

ADA ID: RPRK220124115431 Ramp Type: Type 4 - Parallel Initial Pass/Fail: Fail Overall Compliance: No Severity Score: 30

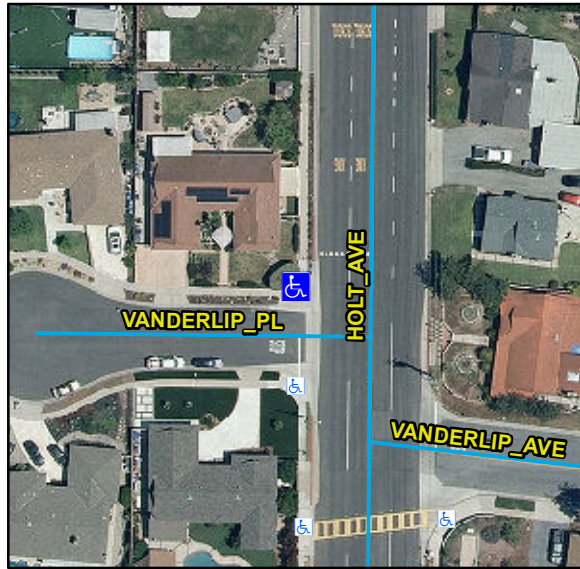
| Compliance | Description | Data | Compliance | Description | Data |
|---|---|---|---|---|---|
| N/A | Ramp Length LT (in) | 114 | N/A | Ramp Length RT (in) | 105 |
| Yes | Ramp Width LT (in) | 89 | Yes | Ramp Width RT (in) | 89 |
| No | Ramp Run Slope LT (%) | 8.6 | Yes | Ramp Run Slope RT (%) | 8 |
| No | Ramp Cross Slope LT (%) | 5.3 | No | Ramp Cross Slope RT (%) | 5.2 |
| | Crossing 1 Slope (%) | 3.4 | | Crossing 2 Slope (%) | 7.7 |
| | Crossing 1 Cross Slope (%) | 3.6 | | Crossing 2 Cross Slope (%) | 0.9 |

Remove & Replace Curb Ramp With Two New Directional Ramps or Equivalent.

R304.3.2, R304.5.3, STD 1115

Total Cost: \$ 4000
