# Access Compliance Report Public Rights-of-Way (Curb Ramps)

Main Street: VANDERLIP\_AVE Cross Street: HOLT\_AVE Location: SE

ADA ID: RPRK220124115929 Ramp Type: Type 4 - Parallel Initial Pass/Fail: Fail Overall Compliance: No Severity Score: 30

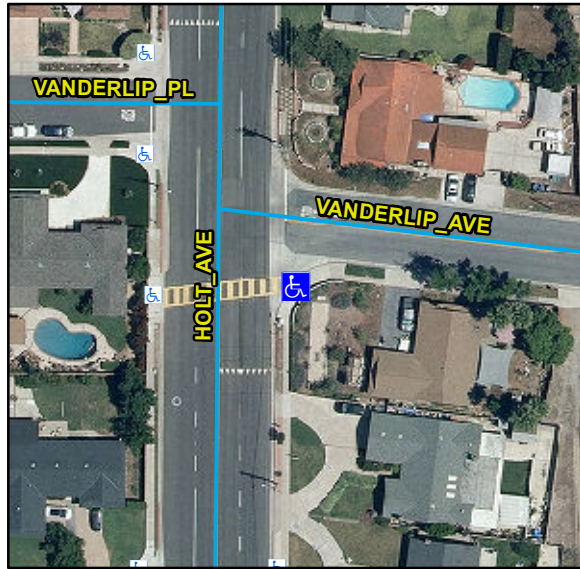
| Compliance | Description | Data | Compliance | Description | Data |
|---|---|---|---|---|---|
| No | Ramp Cross Slope LT (%) | 7.5 | No | Ramp Cross Slope RT (%) | 6 |

Remove & Replace Curb Ramp With Two New Directional Ramps or Equivalent. Restripe Crosswalk.
