# Access Compliance Report Public Rights-of-Way (Curb Ramps)

Main Street: HOLT\_AVE Cross Street: WELLINGTON\_AVE Location: SW

ADA ID: RPRK220124120213 Ramp Type: Type 4 - Parallel Initial Pass/Fail: Fail Overall Compliance: No Severity Score: 2

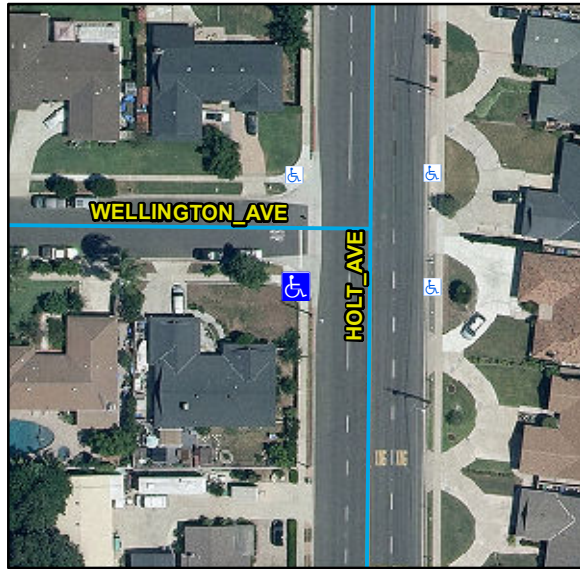
| Compliance | Description | Data | Compliance | Description | Data |
|---|---|---|---|---|---|
| No | Ramp Cross Slope LT (%) | 3 | Yes | Ramp Cross Slope RT (%) | 1.3 |

**Remove & Replace Curb Ramp With Two New Directional Ramps or Equivalent.**

**R304.5.3, STD 1115**
