# Access Compliance Report Public Rights-of-Way (Curb Ramps)

Main Street: LAMBETH\_WAY Cross Street: WESTON\_PL Location: NE

ADA ID: RPRK220124121643 Ramp Type: Type 4 - Parallel Initial Pass/Fail: Fail Overall Compliance: No Severity Score: 15

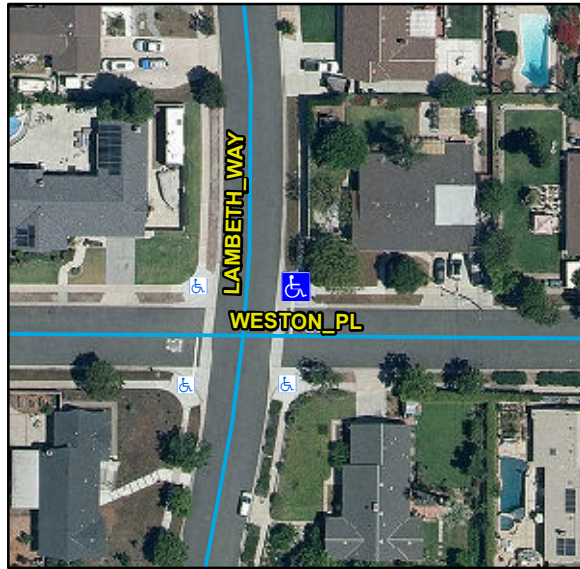
| Compliance | Description | Data | Compliance | Description | Data |
|---|---|---|---|---|---|
| Yes | Ramp Run Slope LT (%) | 2.1 | Yes | Ramp Run Slope RT (%) | 7.6 |
| No | Ramp Cross Slope LT (%) | 5.3 | No | Ramp Cross Slope RT (%) | 4.6 |

**Remove & Replace Curb Ramp With Two New Directional Ramps or Equivalent.**

**R304.5.3, STD 1115**
