# Access Compliance Report Public Rights-of-Way (Curb Ramps)

Main Street: WESTON\_PL Cross Street: LAMBETH\_WAY Location: NW

ADA ID: RPRK220124121955 Ramp Type: Type 4 - Parallel Initial Pass/Fail: Fail Overall Compliance: No Severity Score: 2

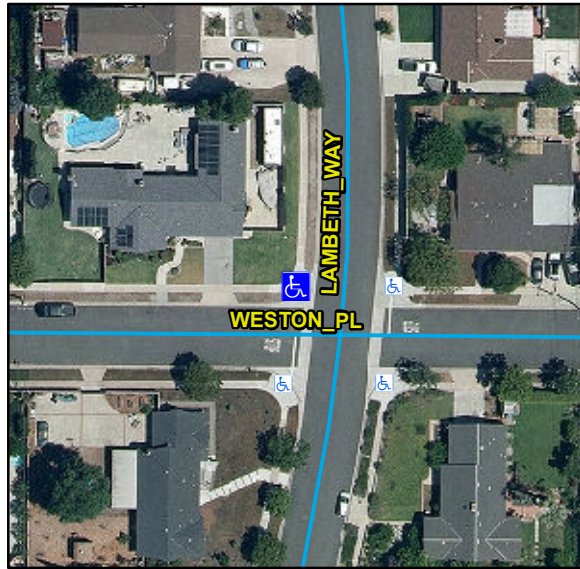
| Compliance | Description | Data | Compliance | Description | Data |
|---|---|---|---|---|---|
| No | Ramp Cross Slope LT (%) | 4 | Yes | Ramp Cross Slope RT (%) | 1.2 |

**Remove & Replace Curb Ramp With Two New Directional Ramps or Equivalent.**

**R304.5.3, STD 1115**
