# Access Compliance Report Public Rights-of-Way (Curb Ramps)

Main Street: LIVINGSTON\_AVE Cross Street: WESTON\_PL Location: NE

ADA ID: RPRK220124122232 Ramp Type: Type 4 - Parallel Initial Pass/Fail: Fail Overall Compliance: No Severity Score: 2

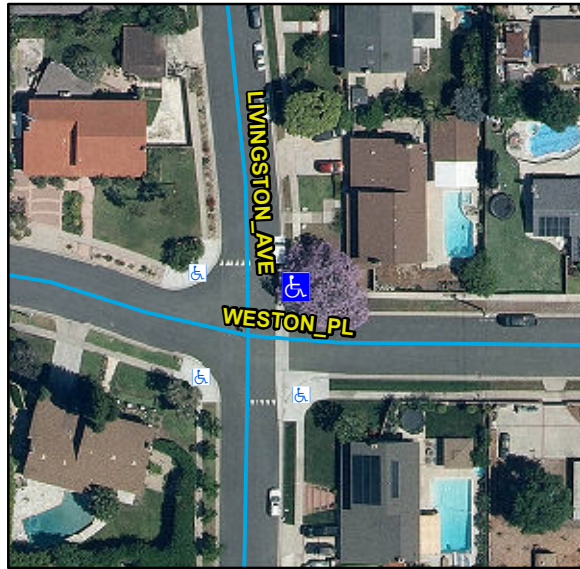
| Compliance | Description | Data | Compliance | Description | Data |
|---|---|---|---|---|---|
| Yes | Ramp Cross Slope LT (%) | 1.9 | No | Ramp Cross Slope RT (%) | 3.2 |

Remove & Replace Curb Ramp With Two New Directional Ramps or Equivalent.

R304.5.3, STD 1115
