# Access Compliance Report Public Rights-of-Way (Curb Ramps)

Main Street: LAMBETH\_WAY Cross Street: WESTON\_PL Location: SW

ADA ID: RPRK220124122622 Ramp Type: Type 4 - Parallel Initial Pass/Fail: Fail Overall Compliance: No Severity Score: 15

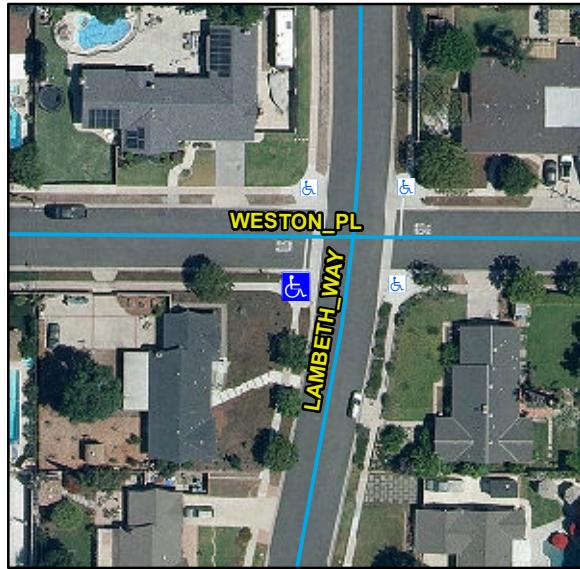
| Compliance | Description | Data | Compliance | Description | Data |
|---|---|---|---|---|---|
| No | Ramp Cross Slope LT (%) | 5 | No | Ramp Cross Slope RT (%) | 5.1 |

**Remove & Replace Curb Ramp With Two New Directional Ramps or Equivalent.**

**R304.5.3, STD 1115**
