# Access Compliance Report Public Rights-of-Way (Curb Ramps)

| Main Street: WESTON_PL | | Cross Street: LAMBETH_WAY | | Location: | SE |
| ADA ID: RPRK220124123025 | Ramp Type: Type 4 - Parallel | Initial Pass/Fail: Fail | Overall Compliance: No | Severity Score: | 2 |

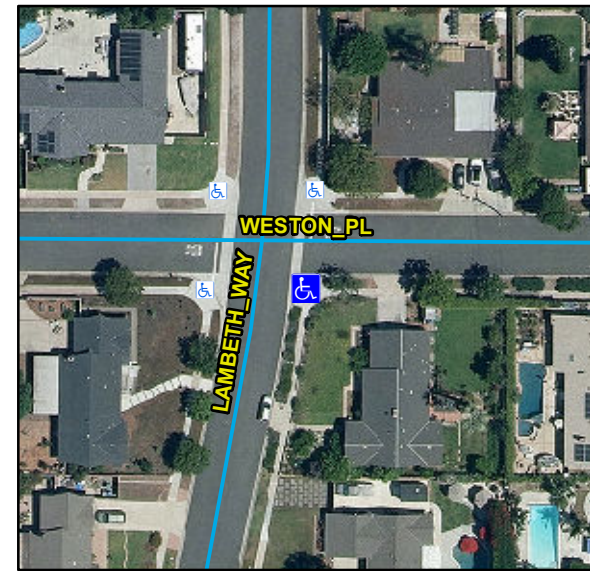
| Compliance | Description | Data | Compliance | Description | Data |
|---|---|---|---|---|---|
| No | Ramp Cross Slope LT (%) | 4.8 | No | Ramp Cross Slope RT (%) | 4.7 |

**Remove & Replace Curb Ramp With Two New Directional Ramps or Equivalent.**

**R304.5.3, STD 1115**
