# Access Compliance Report Public Rights-of-Way (Curb Ramps)

Main Street: N/A Cross Street: LA\_COLINA\_DR Location: W

ADA ID: RPRK220125114355 Ramp Type: Type 1 - Perpendicular Diagonal Initial Pass/Fail: Fail Overall Compliance: No Severity Score: 32

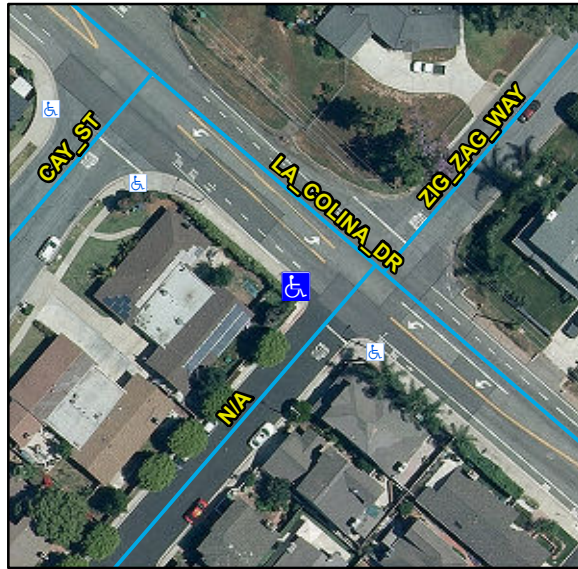
| Compliance | Description | Data | Compliance | Description | Data |
|---|---|---|---|---|---|
| No | Ramp Run Slope (%) | 13.3 | N/A | Flare Slope LT (%) | N/A |
| No | Ramp Cross Slope (%) | 2.2 | N/A | Flare Traversable LT | N/A |
| No | Gutter Lip Height (in) | 0.5 | | Road Run Slope (%) | 0.7 |

Remove & Replace Curb Ramp With Two New Directional Ramps or Equivalent.
