# Access Compliance Report Public Rights-of-Way (Curb Ramps)

Main Street: LA\_COLINA\_DR Cross Street: N/A Location: S

ADA ID: RPRK220125114641 Ramp Type: Type 1 - Perpendicular Diagonal Initial Pass/Fail: Fail Overall Compliance: No Severity Score: 30

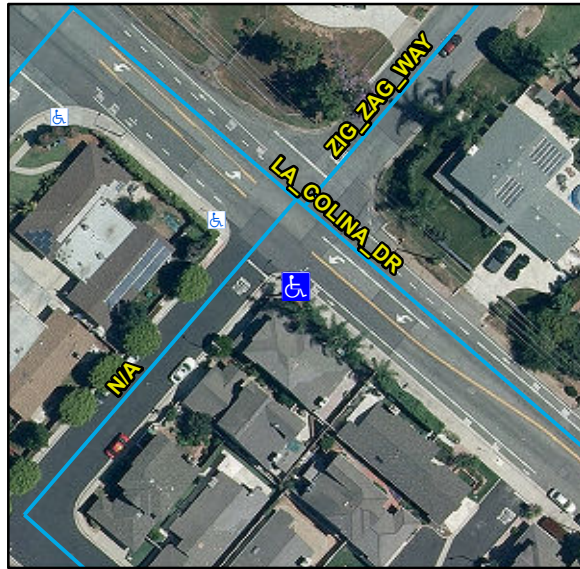
| Compliance | Description | Data | Compliance | Description | Data |
|---|---|---|---|---|---|
| No | Ramp Run Slope (%) | 10.3 | N/A | Flare Slope LT (%) | N/A |
| No | Ramp Cross Slope (%) | 6.3 | N/A | Flare Traversable LT | N/A |
| No | Gutter Lip Height (in) | 0.5 | | Road Run Slope (%) | 3 |

Remove & Replace Curb Ramp With Two New Directional Ramps or Equivalent. Grind Gutter Lip.

R304.2.2, R304.5.3, R302.7.2, STD 1115
